From: [Karen Izzo](#)
To: [Brady Smith](#)
Cc: [Laurie Sobel](#)
Subject: Re: 3-9-22 MCADB Meeting Update
Date: Friday, March 11, 2022 9:37:33 PM
Attachments: [image001.jpg](#)

From: [Karen Izzo](#)
To: [Brady Smith](#); [Laurie Sobel](#)
Subject: CADB hearing
Date: Monday, March 14, 2022 12:57:37 PM
Attachments: [IMG_3909.jpg](#)
[IMG_3903.jpg](#)
[IMG_3900.jpg](#)
[IMG_3898.jpg](#)
[IMG_3893.jpg](#)
[IMG_3897.jpg](#)
[IMG_3910.jpg](#)
[IMG_3915.jpg](#)
[IMG_3912.jpg](#)
[IMG_3907.jpg](#)
[IMG_3914.jpg](#)

The following comments and the attached documents are submitted to the hearing record concerning our complaint regarding the agricultural practices used for soil erosion by our neighbor at 53 Cranbury Neck Road. I will provide a more detailed explanation of each photo and document during the hearing but I will offer some summary comments here below.

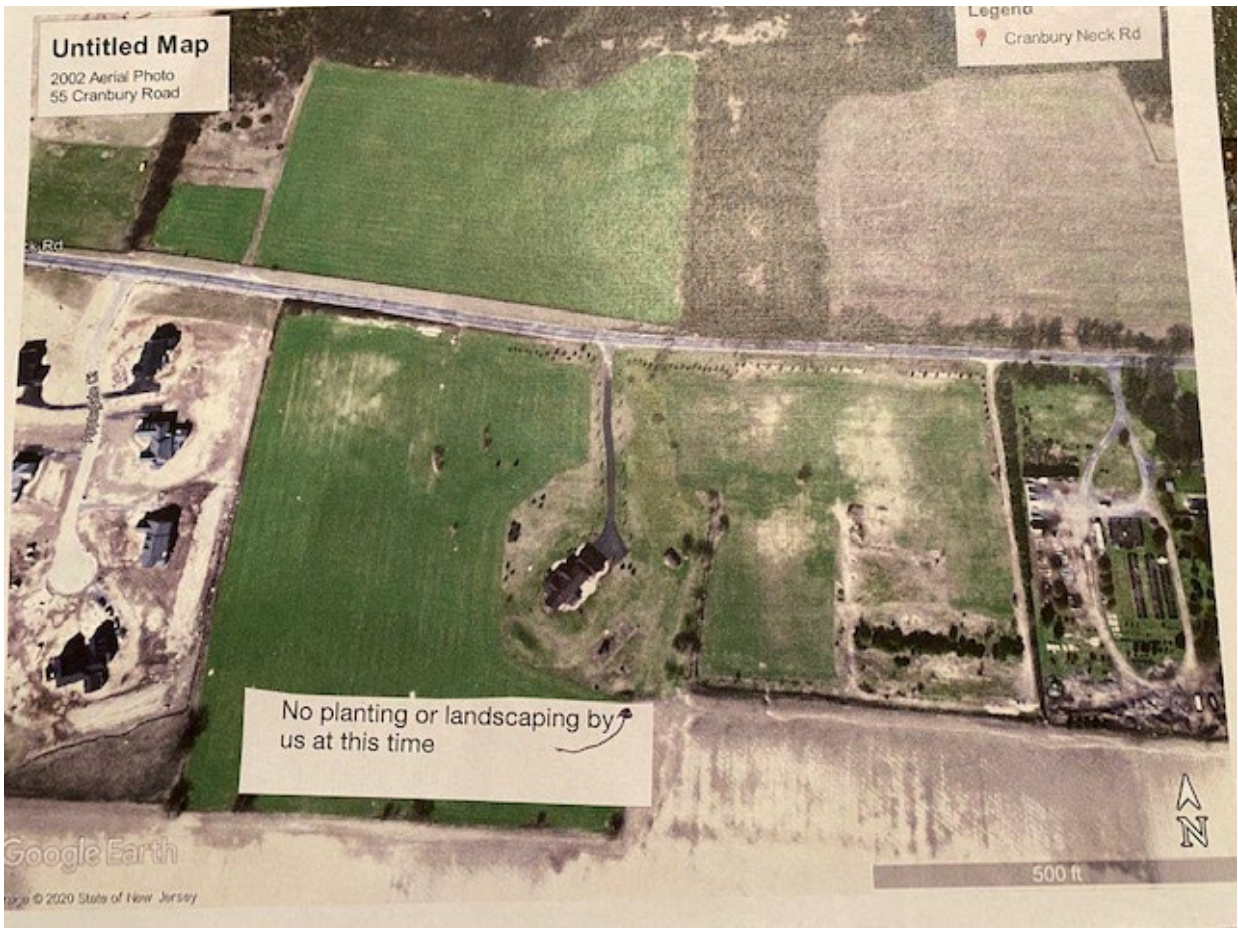
IMG_3900

IMG_3900. This 2002 photo is 3 years after we have moved into our home. Notice there are no plantings at our shared southern corner. There is runoff onto our property from the south and runoff onto our neighbor's property from the east. The water crosses our neighbor's property at the lowest point along his southern border which is also where the greatest erosion occurred. Both of these flows are consistent with topographical maps of the properties.

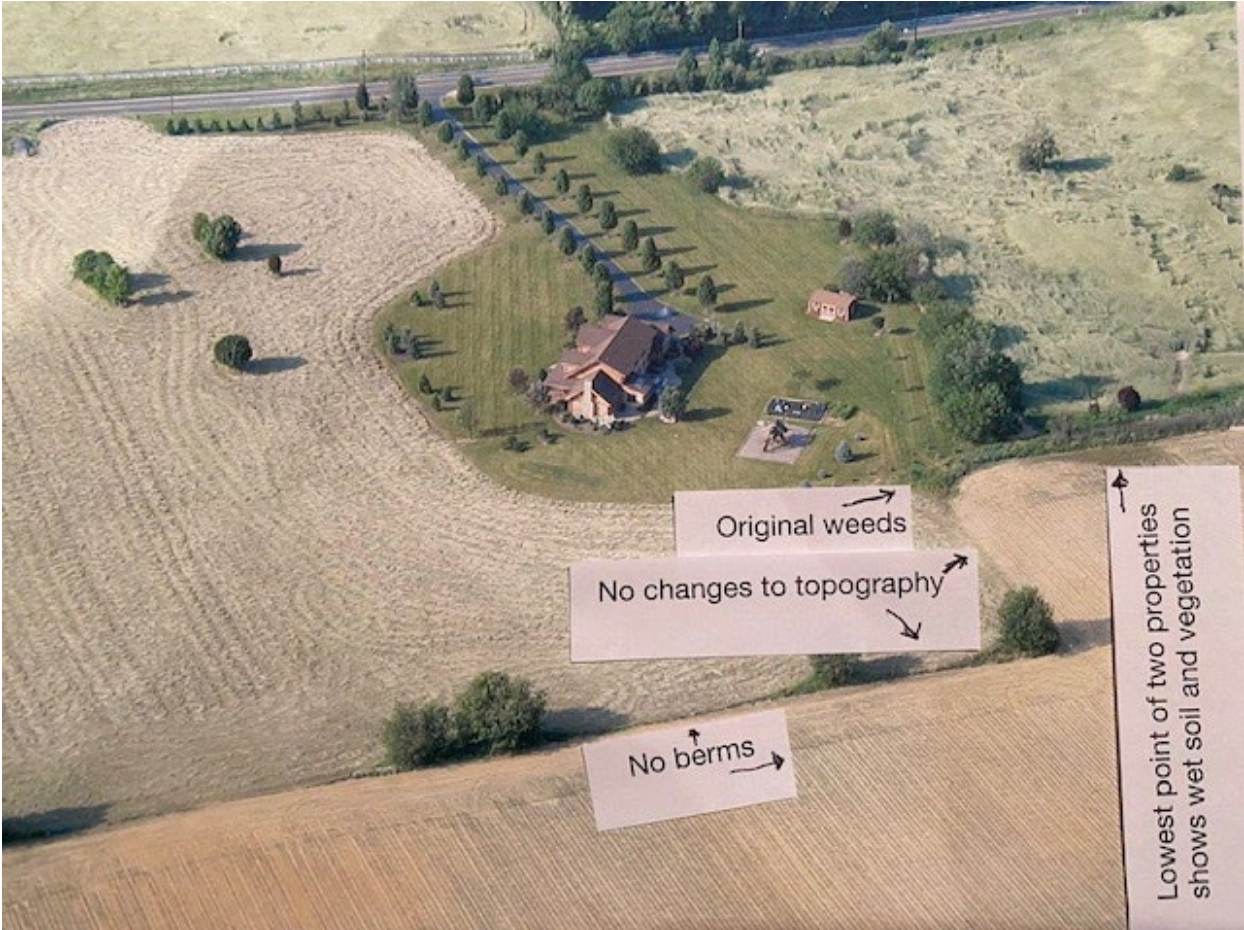
IMG_3893 and 3897. These two aerial photos are undated. We know for certain they were taken before 2012 because Superstorm Sandy caused major damage along our driveway and many trees were lost. This picture shows those trees still standing. Please notice the absence of any landscaping at the shared corner with our neighbor, clear vegetation and a low lying area well onto his southern border that corresponds with his more recent erosion, and the complete absence of any visible changes to our border with the Barton farm. These photos completely discredit the unsubstantiated claims made by our neighbor in his presentation to the Board.
